Report of  
Dam Safety Assessment of Coal Combustion  
Surface Impoundments

Kentucky Utilities,  
a wholly owned subsidiary of LG&E and KU Energy LLC

Pineville Generating Station, Pineville, KY

AMEC Project No. 3-2106-0177.0003

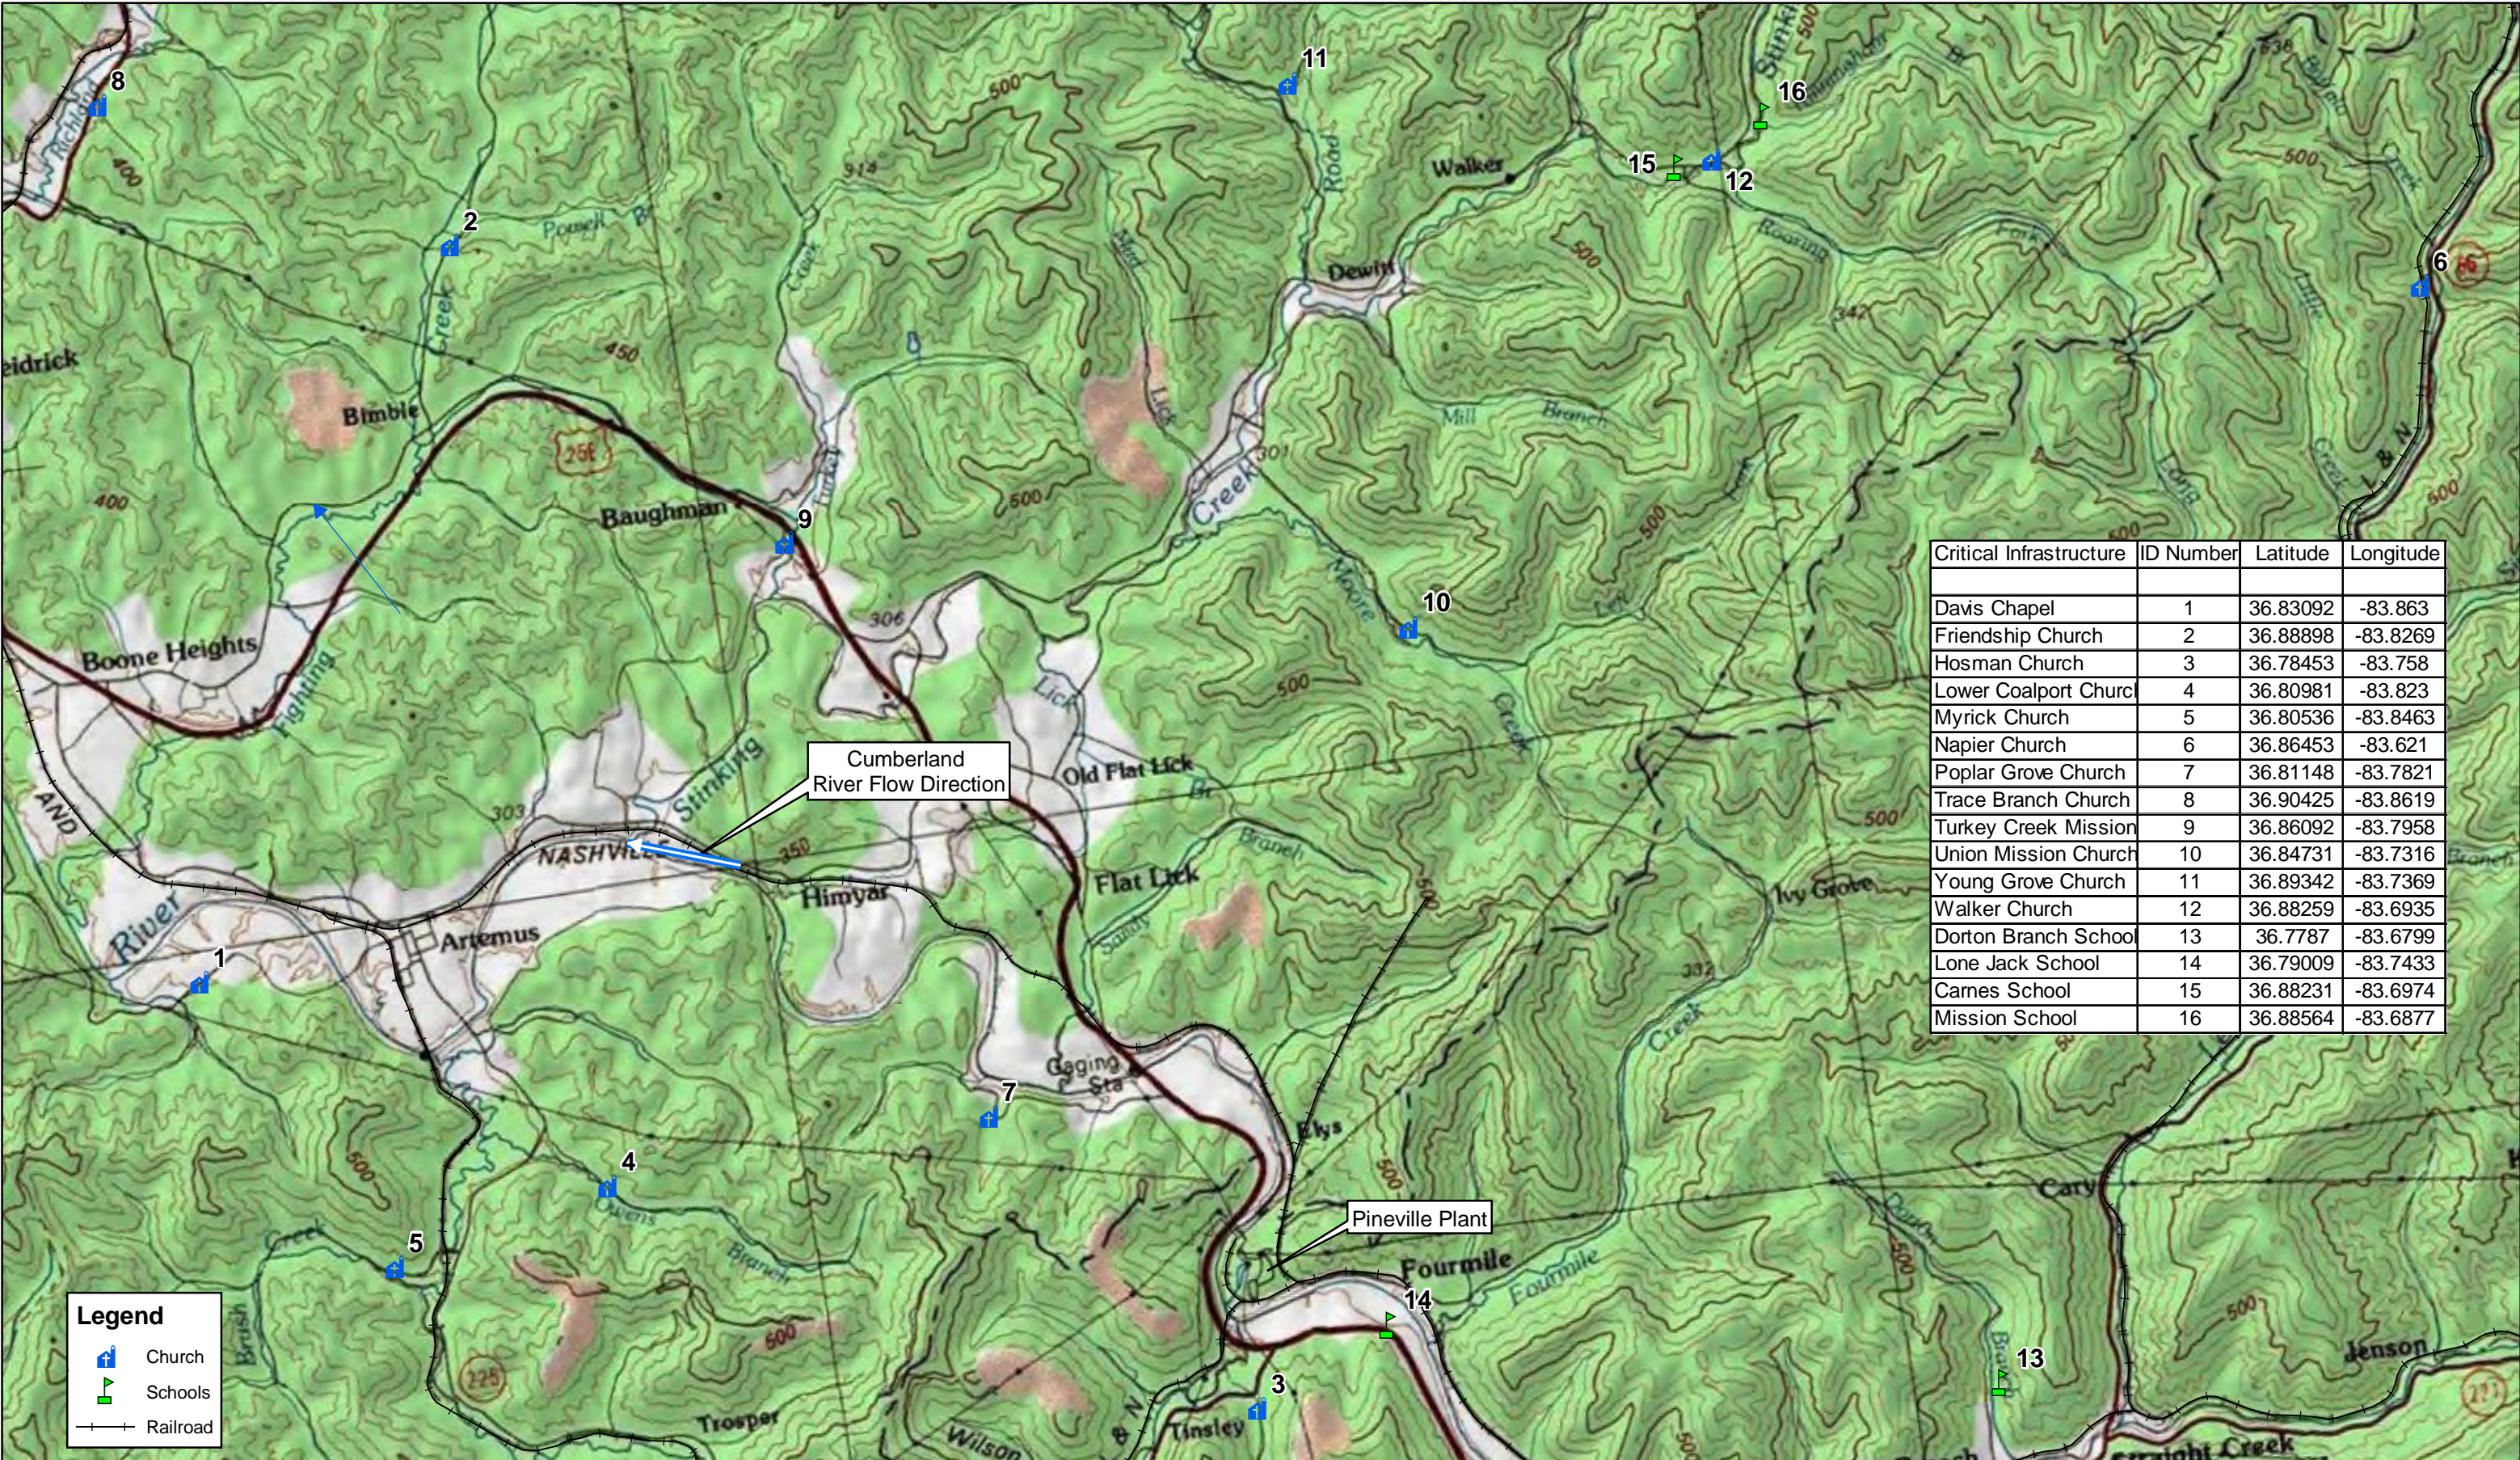
FIGURE  
3

An aerial photograph of the region indicating the location of Pineville Generating Station ash pond in relation to schools, hospitals, and other critical infrastructure located within approximately 5 miles down gradient of the structures is included as Figure 3, the Critical Infrastructure Map. A table that provides names and coordinate data for the infrastructure is included on the map.

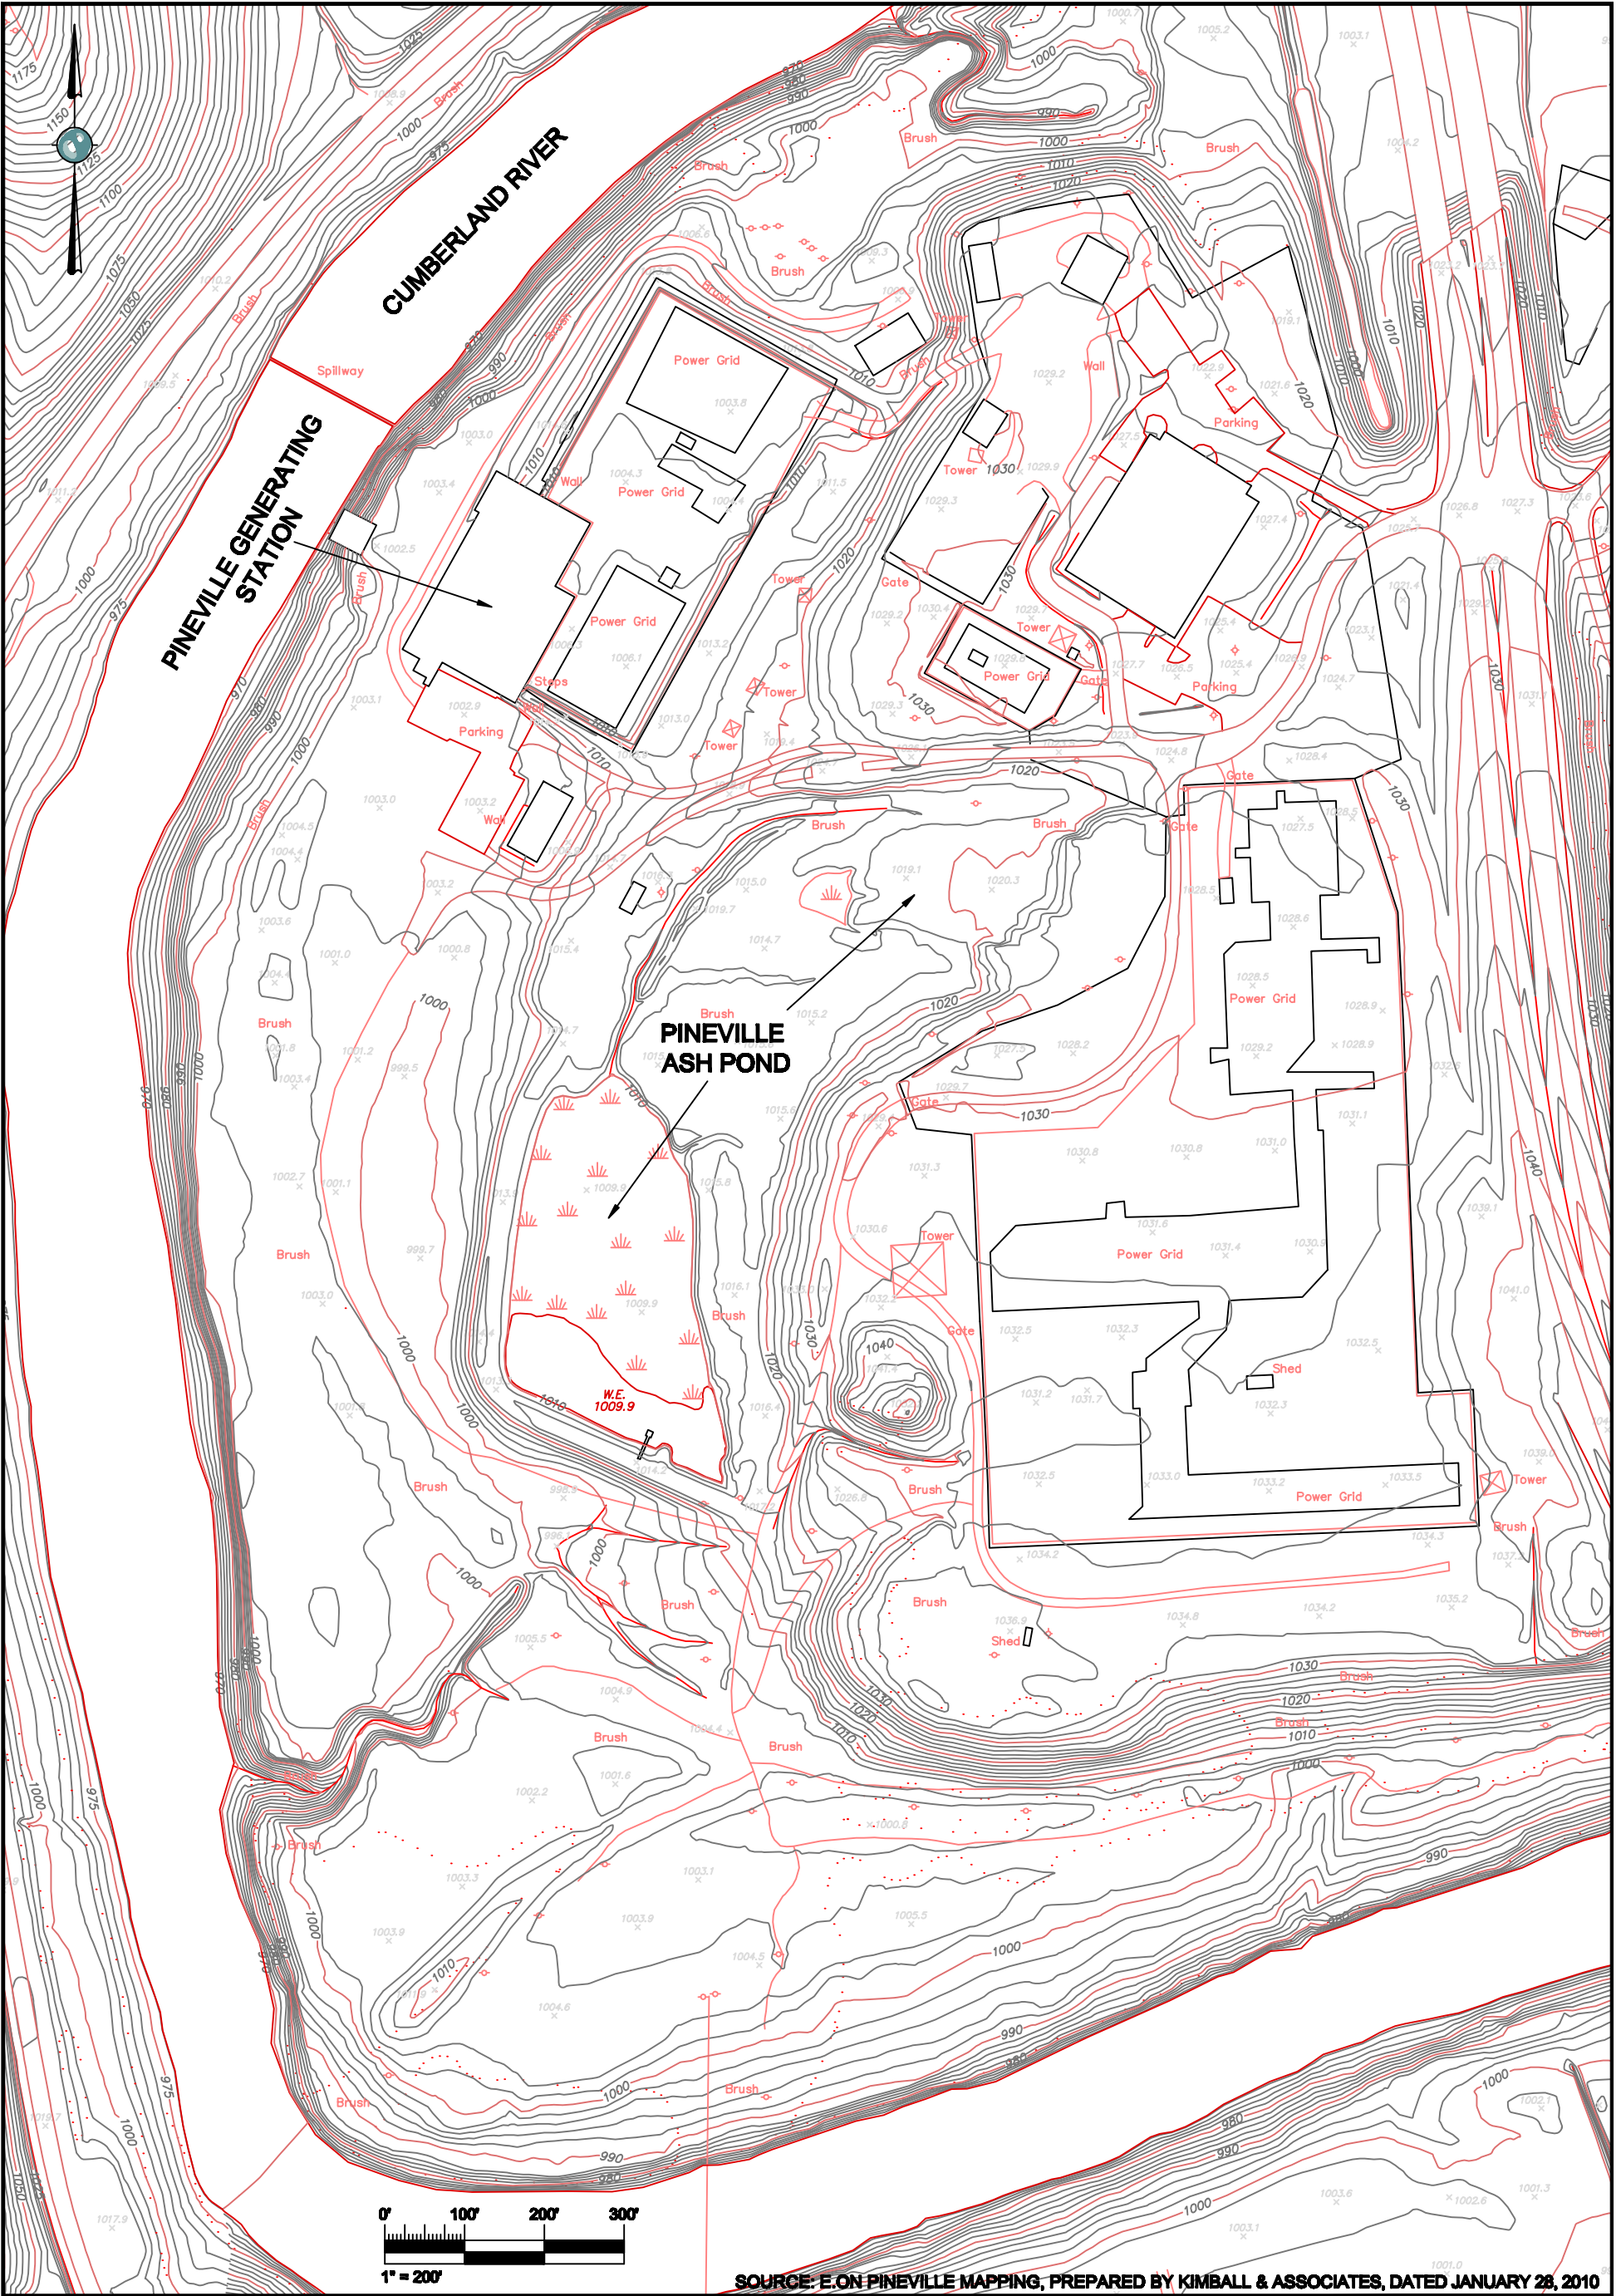
DATUM:	TITLE KENTUCKY UTILITIES, SUBSIDIARY OF E.ON U.S. PINEVILLE GENERATING STATION, PINEVILLE, KY TOPOGRAPHIC MAP		PROJECT NO: 3-2106-0177-0003
				PROJECTION:			FIGURE No. 7
				SCALE:			
				AS SHOWN

A topographic plan view of the Pineville Ash Pond is included as Figure 7. This figure is based on a ground control survey dated December 22, 2009 by Kimball Associates, Inc. to provide KU with more accurate embankment elevations and other useful information regarding the facilities.
